ANYTOWN USA

CENTRAL SCHOOL DISTRICT

- Technology Condition Survey Report
- Anytown CSD Serving Zone Drawing
- 10-Year Comprehensive Technology Roadmap

July 4, 2025

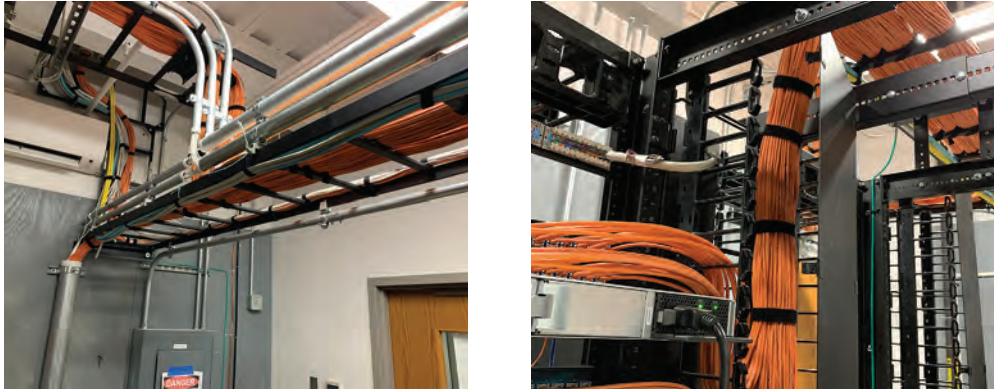
Cable management systems in a TR should accommodate both overhead (right) and vertical (far right) cables.

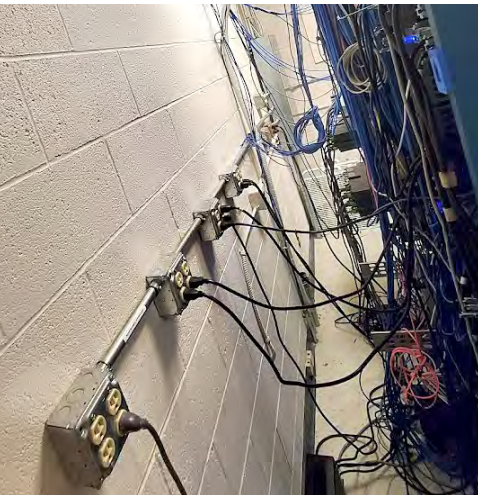
These power cords risk being unplugged when technicians work behind the racks.

Electrical outlets should be mounted to all racks.

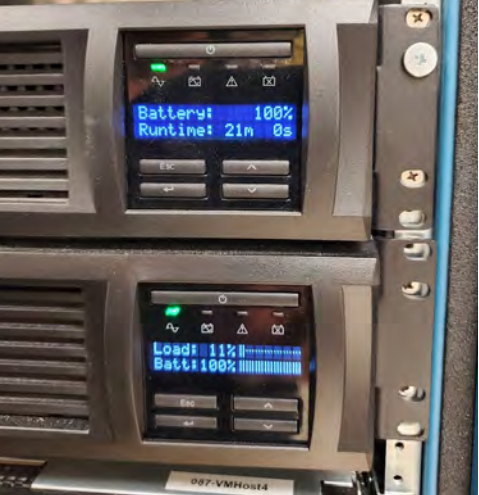
UPS units are rack mounted with no error or alarm messages displayed.

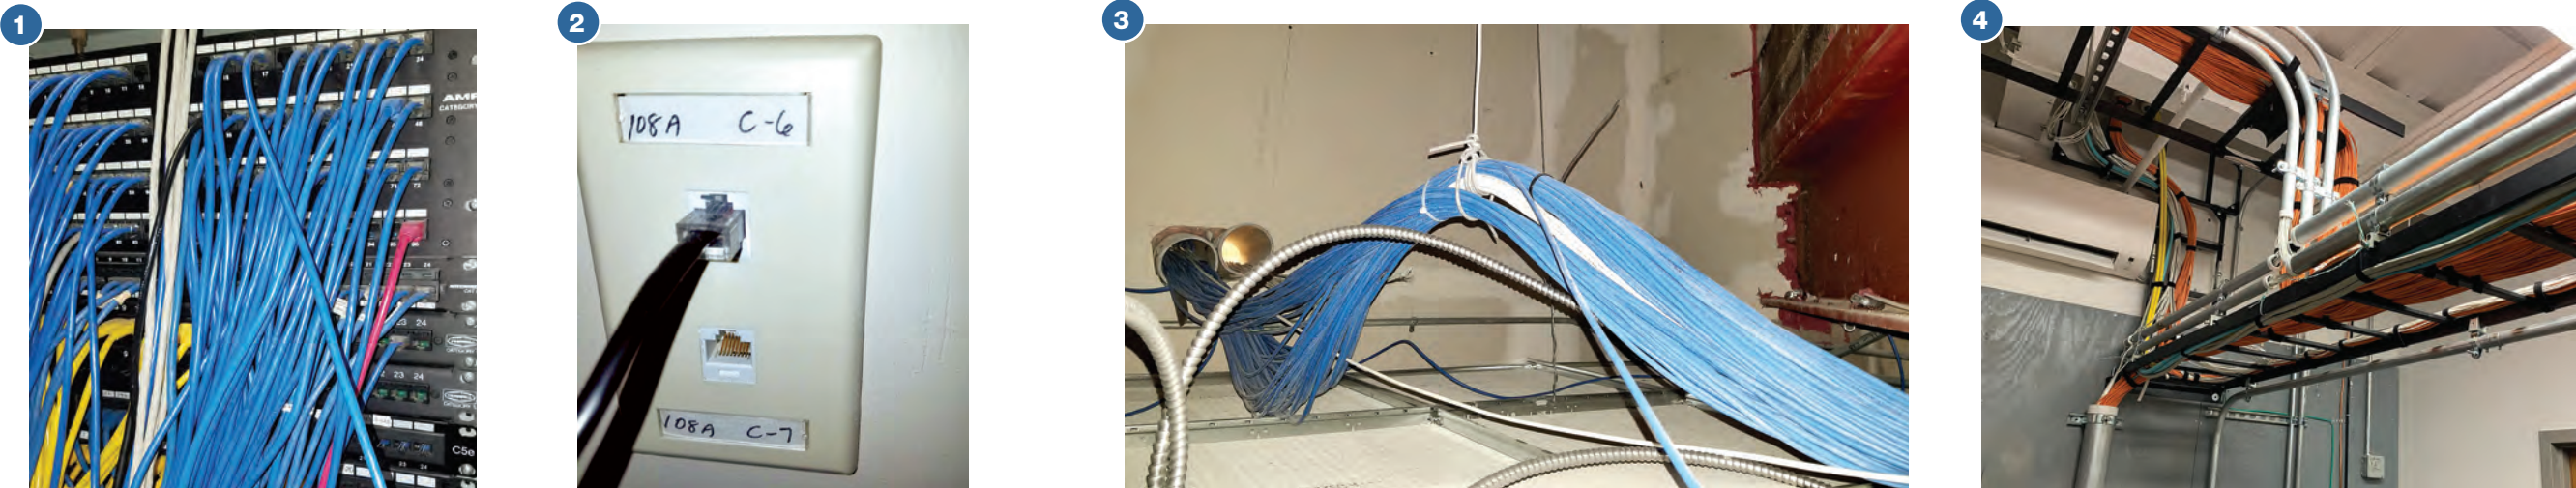
- ES and MS non-compliant horizontal cable management.
- Typical ES and MS cabling with non-compliant labeling.
- Improperly supported horizontal cable in the High School.
- Ladder racking correctly installed and deployed in the MTR - Server Room 154.

4	Cable Counts	Generally, cable counts are adequate for current District needs.	
		2	Cable Labeling	The district lacks cable labeling conventions resulting in inconsistent and inadequate cable labels throughout the district.	
		0	Serving Zones	Serving Zones for each floor are not documented.	
		4	Wireless Access Point (WAP) Cabling	(2) Cat6A cables are installed for each WAP.	
	Backbone Cabling	4	Intra-building Fiber Optic Backbone (within a building)	50-micron Multi Mode (MM) and Single Mode (SM) fiber are installed throughout the building.	No recommendations at this time.
		N/A	Inter-building Fiber Optic Backbone (between buildings)	The district has a single Central School building with no inter-building connections.	
	Communications Pathways	2	Cable Tray	Except for the Main Telecom Room (MTR), there is minimal use of cable tray throughout the District.	<div><div>1. Install new/add cable tray down all corridors and in other areas of the building.</div><div>2. Correctly install all existing and new cable into the tray.</div></div>

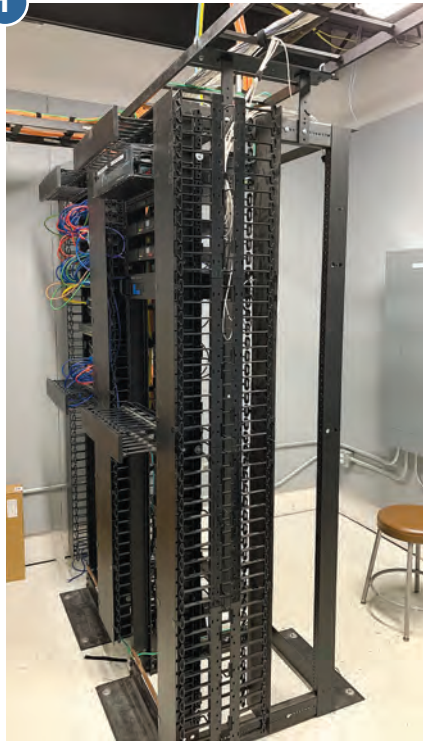
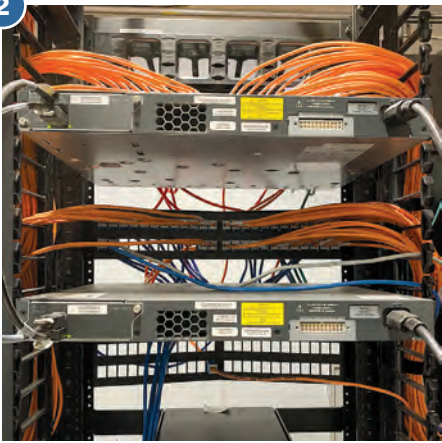
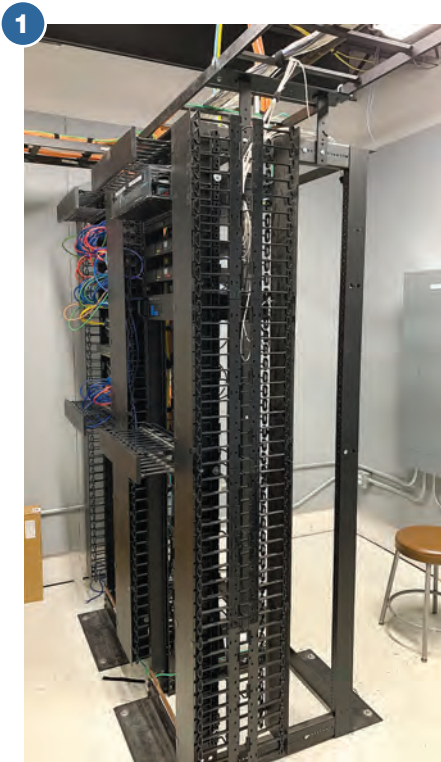
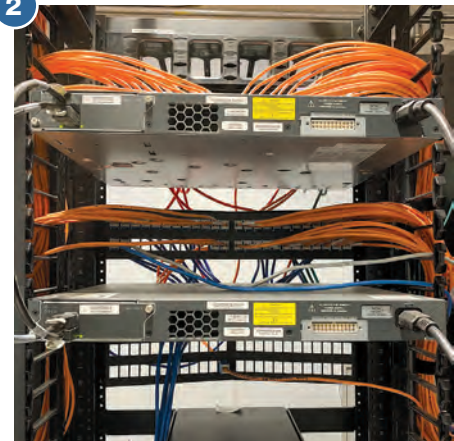
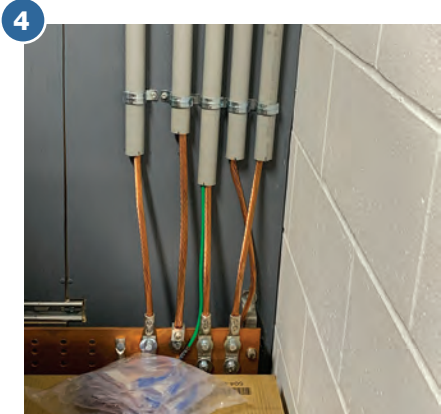
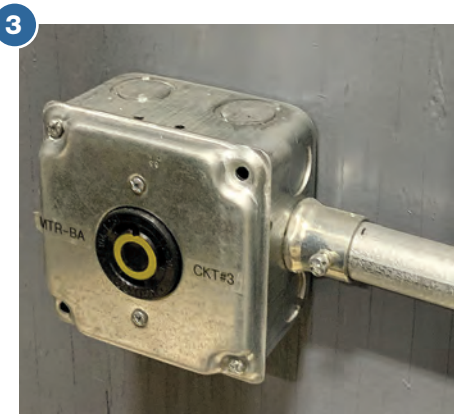
TELECOMMUNICATIONS INFRASTRUCTURE - SPACES: MTR, Server Room (MS 154)					Anytown Central School - MTR, SERVER ROOM (MS 154)				
<div>CURRENT GRADE</div> <div>3.6 out of 4.0</div> <div>CURRENT CONDITION</div> <div>The space is in good condition and requires moderate upgrades to meet industry standards.</div>		<div>RECOMMENDATION</div> <div>Upgrade the current space.</div> <div>ROM COST ESTIMATE</div> <div>\$37,000</div>		<div>Summary of Recommendations</div> <div><ul style="list-style-type: none">Install video surveillance coverage of the door.Properly label all electrical outlets.Install treated plywood and firestop.</div>					
CATEGORY		CATEGORY GRADE		CURRENT CONDITION		RECOMMENDED IMPROVEMENTS

- The dedicated secure space includes (3) newer equipment racks.
- The racks include properly installed cable lengths and management.
- A properly labeled electrical outlet from the building's emergency generator.
- A properly installed grounding bar with all components correctly connected.

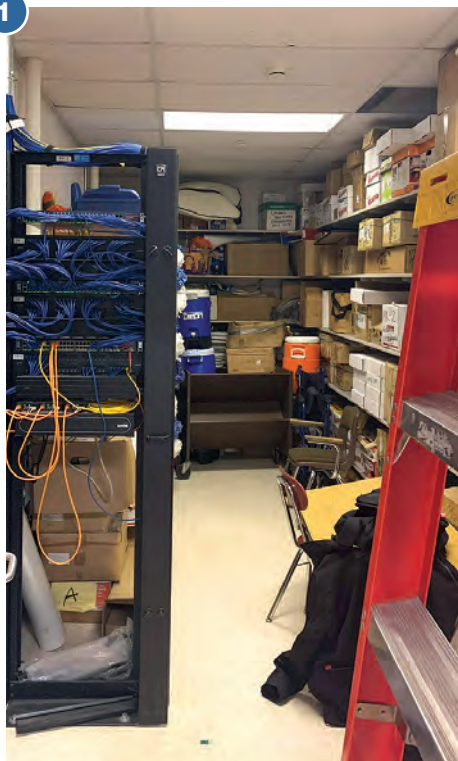
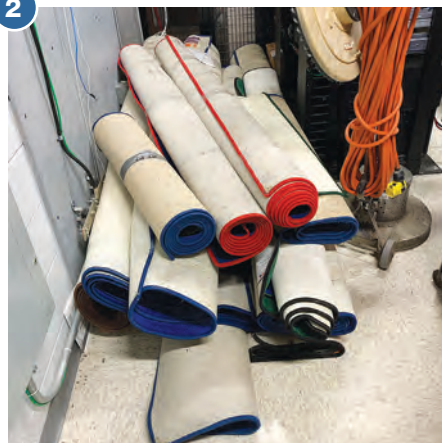
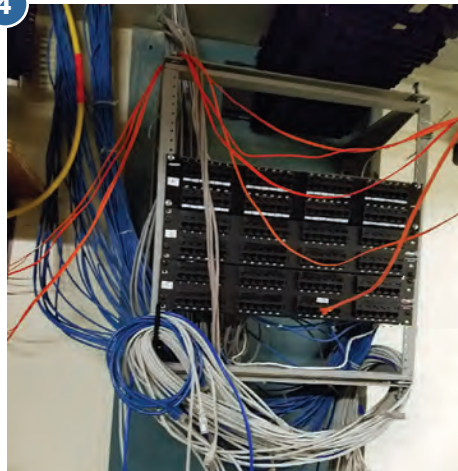
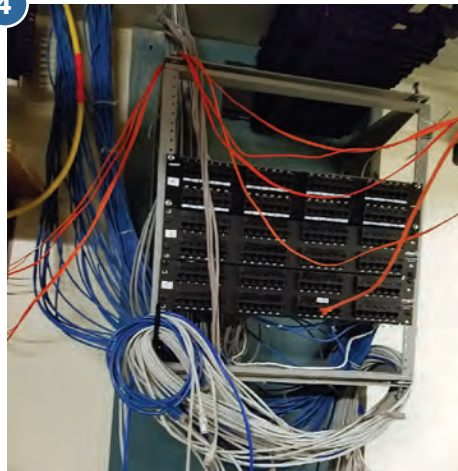
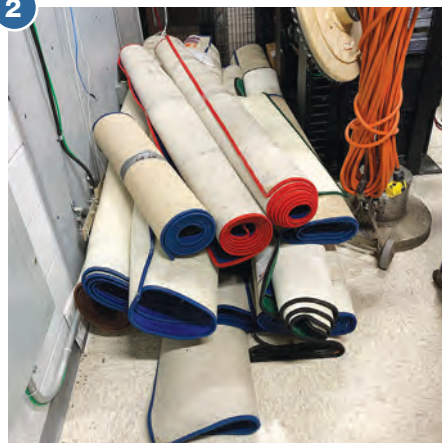
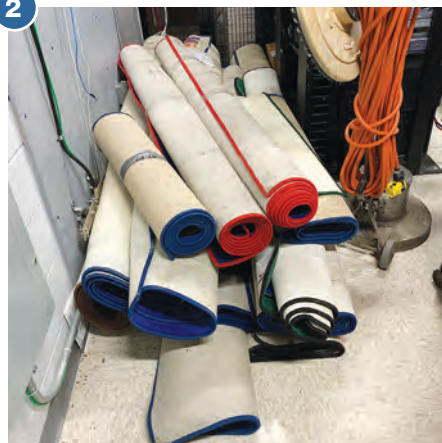
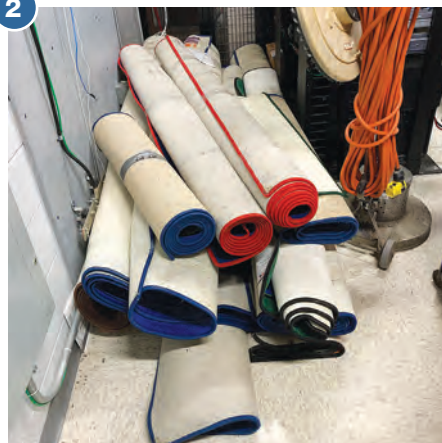
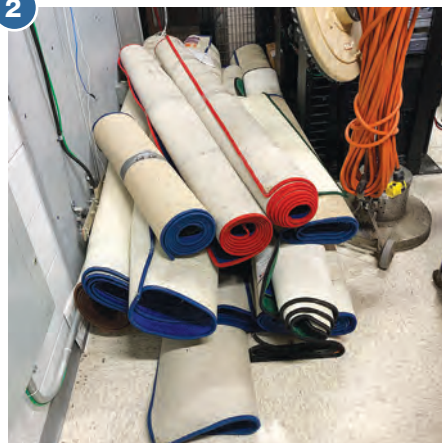
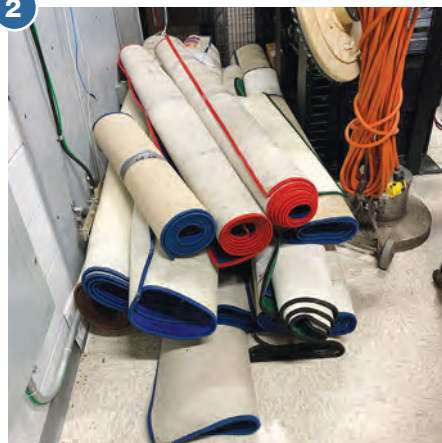
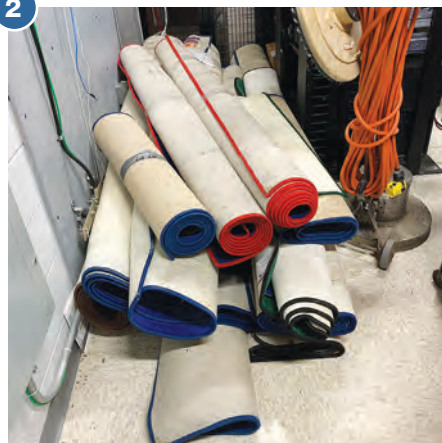
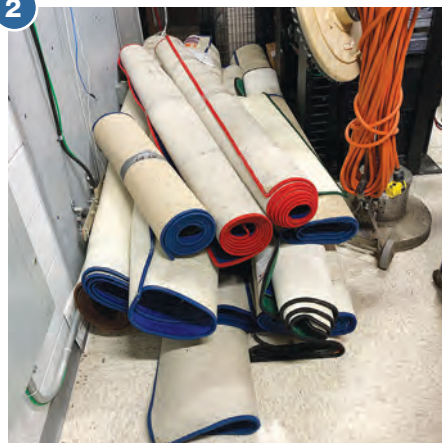
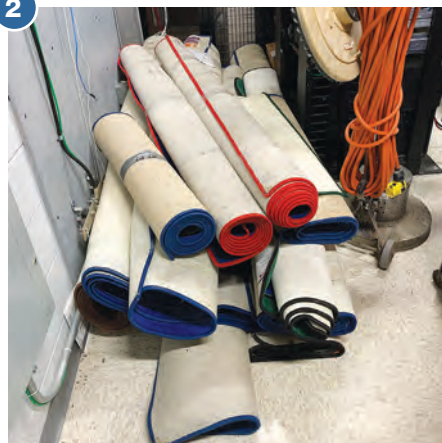
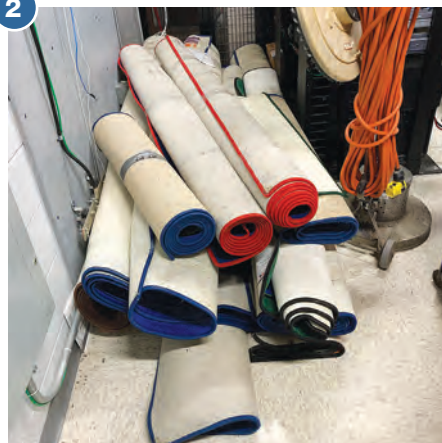
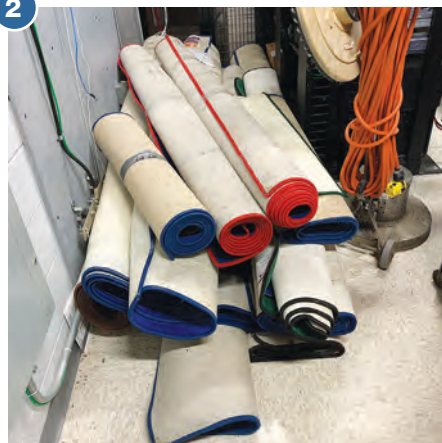
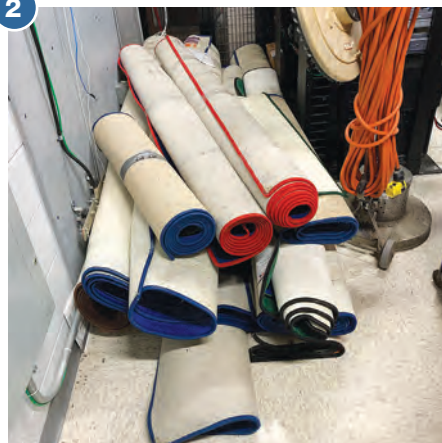
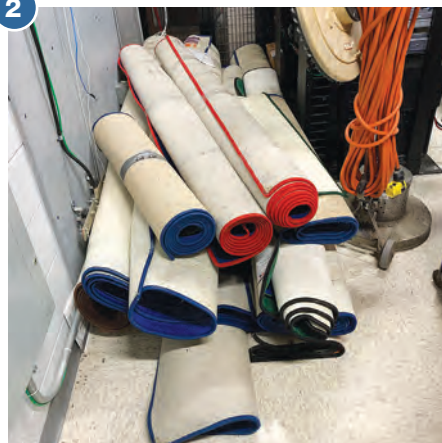
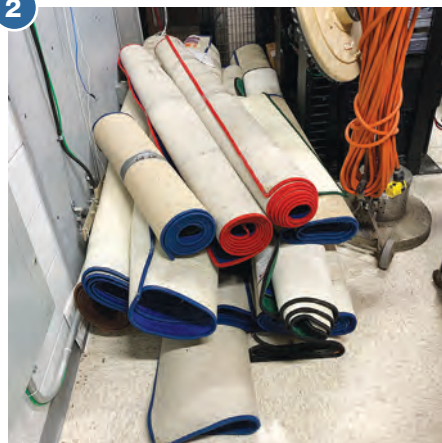
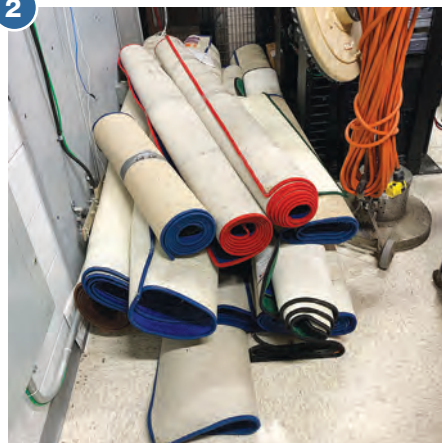
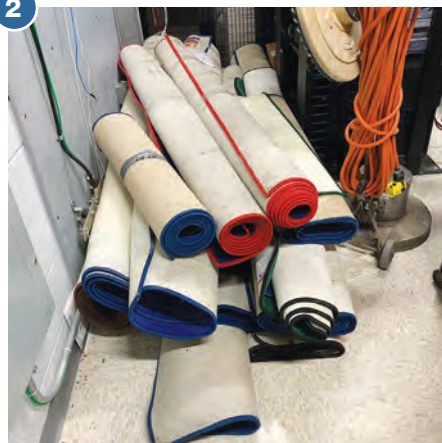
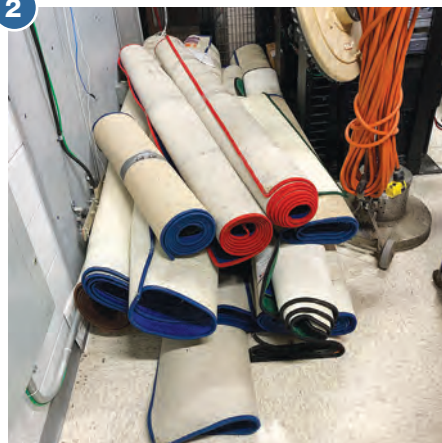
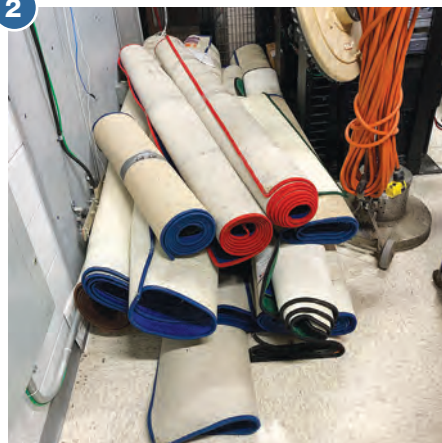
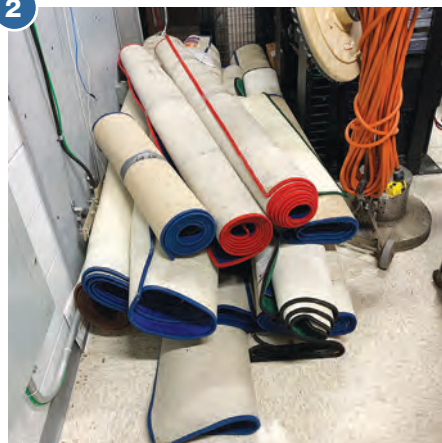
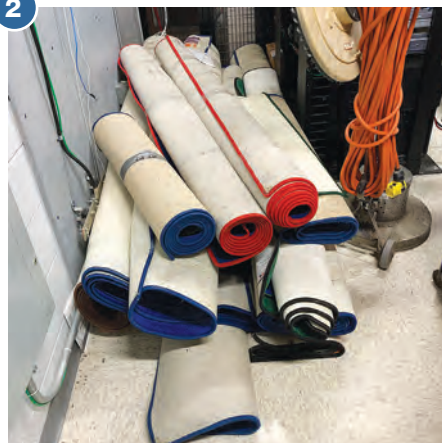
TELECOMMUNICATIONS INFRASTRUCTURE - SPACES: TR-2, Storage Room (HS 104)				Anytown Central School - TR-2, STORAGE ROOM (HS 104)			
<div>CURRENT GRADE</div> <div>1.7 out of 4.0</div> <div>CURRENT CONDITION</div> <div>The space is in poor condition and requires significant upgrades to meet industry standards.</div>		<div>RECOMMENDATION</div> <div>Dedicate and upgrade the current space.</div> <div>ROM COST ESTIMATE</div> <div>\$97,000</div>		<div>Summary of Recommendations</div> <ul style="list-style-type: none">Remove stored non-IT items. Dedicate the space to IT equipment and install card access for IT staff only.Move IT equipment from TR-3, Basement (B 028A) to this space. Recable the equipment in the racks.Installed video surveillance of door exterior.Install AC system, temperature monitoring, a UPS unit, cable management systems, and firestop in conduits.Attach IT equipment to existing rack grounding bar.Install plywood on one wall and remove the drop ceiling.

1. Room Size & Rack Access	2.0	<ul style="list-style-type: none">The room size meets industry standards.The space lacks adequate front and/or rear rack clearances due to its poor configuration and stored non-IT items.	<ul style="list-style-type: none">Remove the stored non-IT items.Dedicate the space to IT equipment and limit access to IT staff.Reposition the rack for adequate clearances.
<div>2</div>

3. Location	2.0	The space lacks direct hallway access and must be entered through a classroom. The space is centrally located in its serving zone.	No recommendations at this time.
<div>4</div>

4. Security	1.0	<ul style="list-style-type: none">The space is shared and accessible to non-IT staff.The network equipment and infrastructure are in an open unlocked equipment rack/cabinet.The space lacks card access and video surveillance coverage.	<ul style="list-style-type: none">Install Access Control card reader keyed for IT staff only.Install a dedicated video surveillance camera focused on the door to the space.

5. Environmental Control	0	The space lacks a dedicated AC system and a temperature monitoring system connected to the network.	Install a dedicated AC system and a temperature monitoring system.
<div>6</div>

6. Dedicated and Redundant Power	3.0	<ul style="list-style-type: none">The circuit is dedicated.(2) unlabeled duplex outlets are installed and an outlet is available.	Properly label all electrical outlets.
<div>7</div>

7. UPS & Emergency Power	0	<ul style="list-style-type: none">There is no UPS installed in the space.While there is a building generator, none of its power connections are in this space.	<ul style="list-style-type: none">Review equipment load to ensure the UPS will provide adequate capacity and run times.Purchase and install a UPS unit as per the 10-Year Roadmap. Connect all equipment to the new UPS.Add labeled electrical connections from the building generator to this space.

8. Grounding Infrastructure	1.0	A proper bonding/grounding infrastructure is installed but no IT equipment is connected to it.	Attach existing IT equipment to the Grounding Bar.
<div>9</div>

9. Overhead Cable Management	1.0	<ul style="list-style-type: none">No overhead cable management system is installed.Cable radius control is lacking.	<ul style="list-style-type: none">Install an overhead cable management system (ladder racks, J hooks) with space for additional capacity.Install a cable radius control system.
<div>10</div>

13. Ceiling	1.0	A drop ceiling is installed less than 10' Above Finished Floor.	Remove the drop ceiling.
<div>GRADING KEY</div> <div>4 Excellent. Meets/exceeds district's current and expected needs.</div>				<div>3 Good. Meets district's current needs but upgrades are needed.</div> <div>2 Fair. Minimally meets current needs. Major upgrades are needed.</div> <div>1 Poor. System is nearing/at end-of-life. Immediate upgrades needed.</div> <div>0 Fail. System is not installed/implemented at the district.</div>

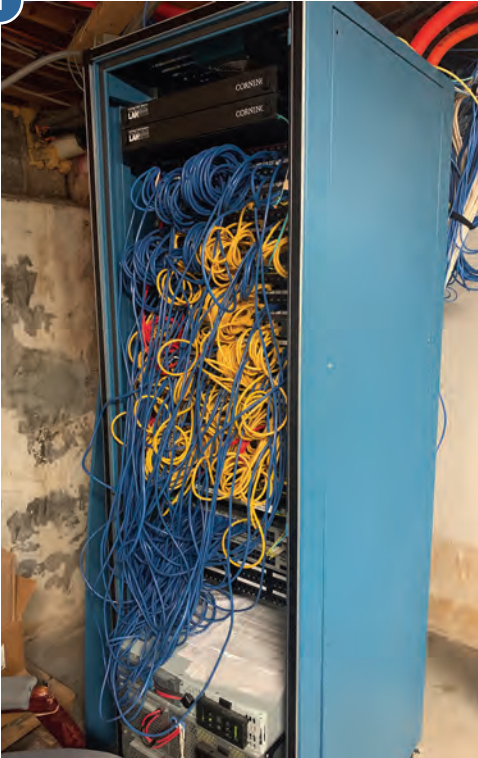
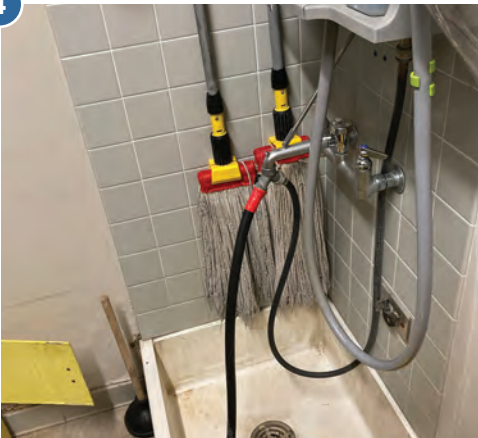
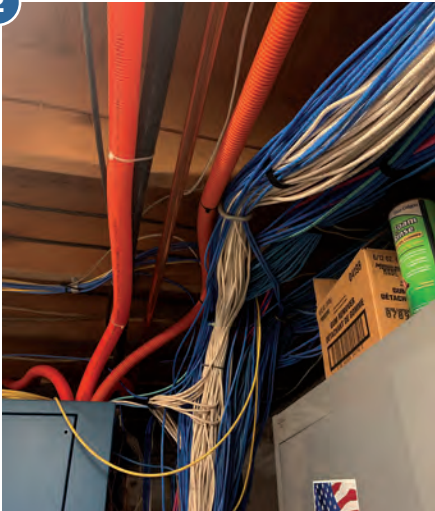
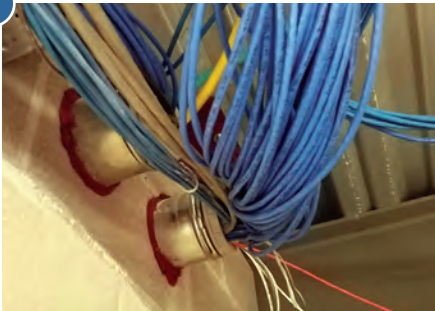
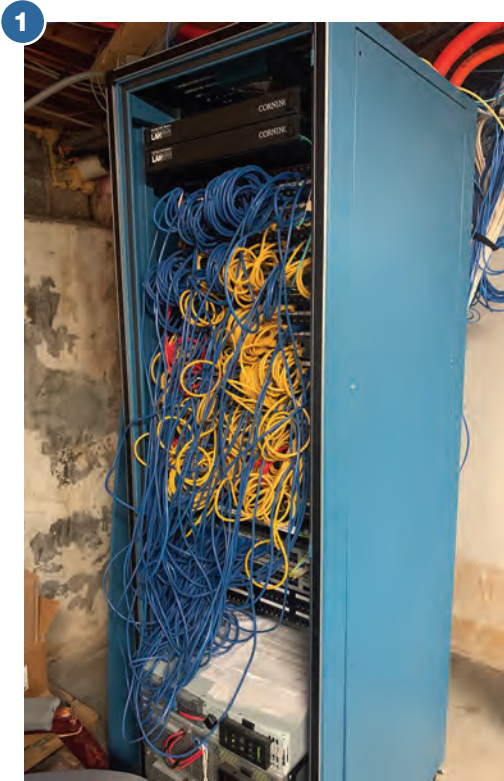
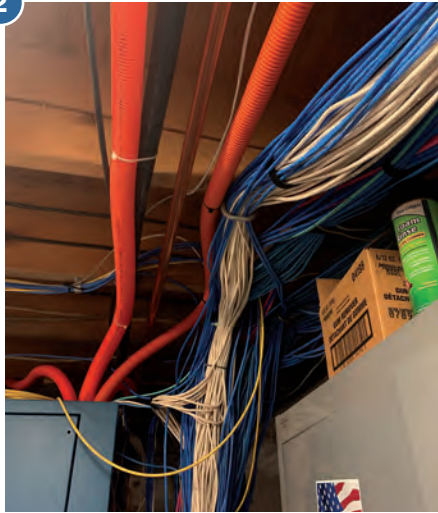
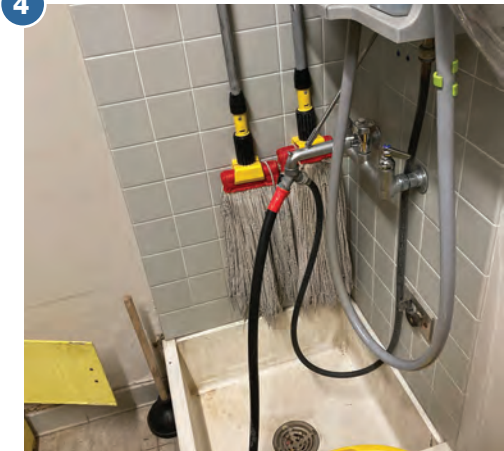
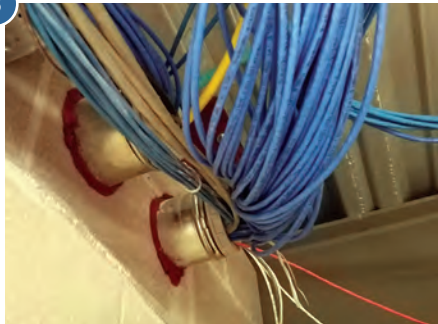
TELECOMMUNICATIONS INFRASTRUCTURE - SPACES: TR-3, Basement (B 048A)					Anytown Central School - TR-3, BASEMENT (B 048A)																																													
<div>CURRENT GRADE</div> <div>0.9 out of 4.0</div> <div>CURRENT CONDITION</div> <div>The space is in poor condition and is not worth the investment to upgrade it to industry standards.</div>		<div>RECOMMENDATION</div> <div>Abandon the current space. Move IT equipment to MTR, Server Room.</div> <div>ROM COST ESTIMATE</div> <div>\$38,000</div>		<div>Summary of Recommendations</div>

<div>Photos, clockwise from top left:</div> <div>1. The open rack is in an unsecured area that is shared with custodial items.</div> <div>2. The space is below grade, a water pipe is installed directly over the rack, and cable management systems are lacking.</div> <div>3. Conduits are filled beyond capacities.</div> <div>4. There is a janitorial slop sink in the same space as the equipment.</div>																																																
<div>4</div>

- The open rack is in an unsecured area that is shared with custodial items.
- The space is below grade, a water pipe is installed directly over the rack, and cable management systems are lacking.
- Conduits are filled beyond capacities.
- There is a janitorial slop sink in the same space as the equipment.

RECOMMENDATION
Abandon the space and move all IT equipment and cables to MTR, Server Room. Remove all abandoned IT equipment and cable; recycle as much as possible.

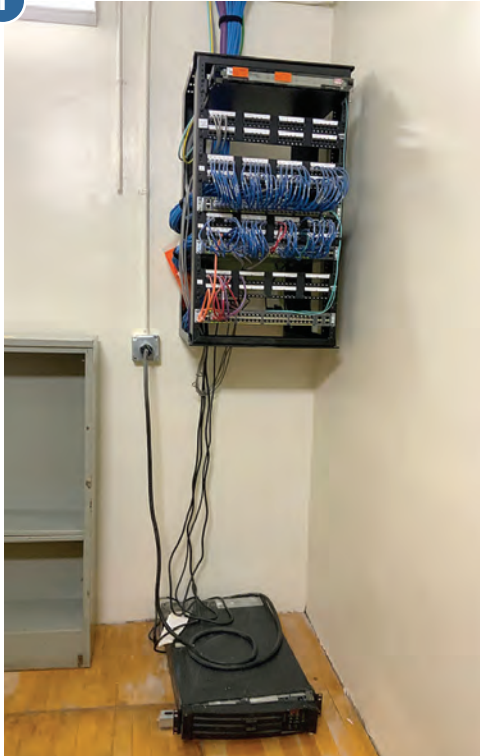
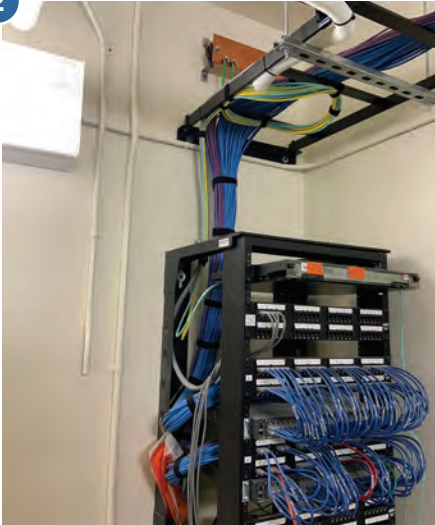
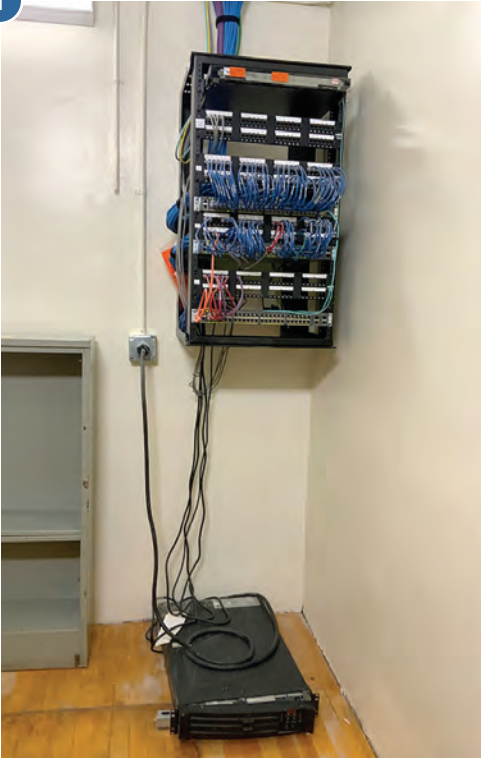
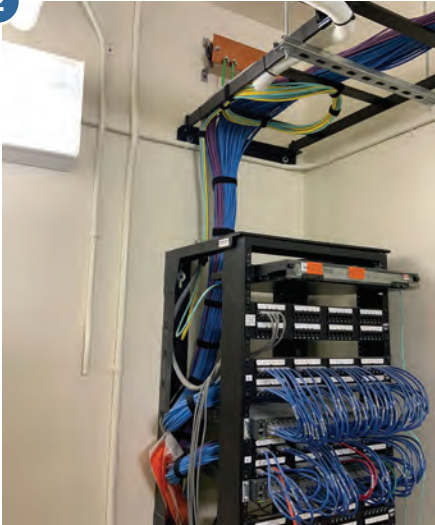
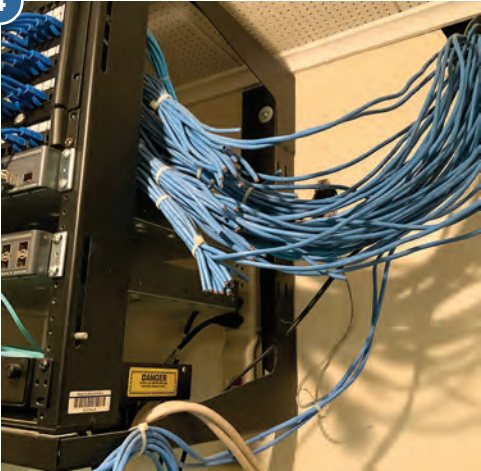
TELECOMMUNICATIONS INFRASTRUCTURE - SPACES: TR-4, District Office (DO 010)					Anytown Central School - TR-4, District Office (DO-010)			
<div>CURRENT GRADE</div> <div>3.2 out of 4.0</div> <div>CURRENT CONDITION</div> <div>The space is in good condition and requires nominal upgrades to meet industry standards.</div>		<div>RECOMMENDATION</div> <div>Upgrade the current space.</div> <div>ROM COST ESTIMATE</div> <div>\$29,000</div>		<div>Summary of Recommendations</div> <div><ul style="list-style-type: none">Install a dedicated video surveillance camera focused on the door to the space.Label emergency power outlets.Install horizontal cable management and cable jacket labels at the rack.Install properly treated plywood, conduit with firestop, and VCT tile flooring.</div>				
CATEGORY		CATEGORY GRADE	CURRENT CONDITION		RECOMMENDED IMPROVEMENTS

- A single wall-mount cabinet is installed in the secured dedicated space.
- Proper vertical and overhead cable management, and grounding systems are used in the space.
- A few non-IT items are stored in the space.
- Horizontal cable supports are lacking at the cabinet and abandoned cables have not been removed from the rack.

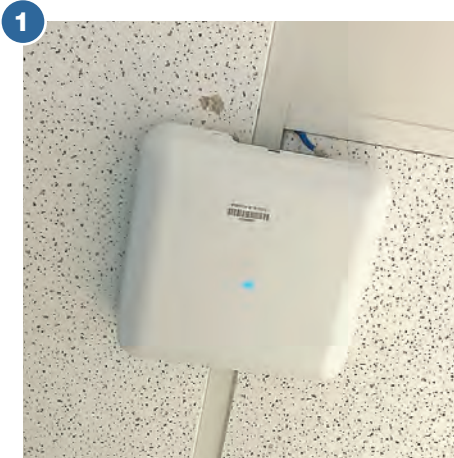
- Photos below:
1. A ceiling-mounted WAP in an Elementary School classroom.
2. The Spectrum internet connection in the MTR.

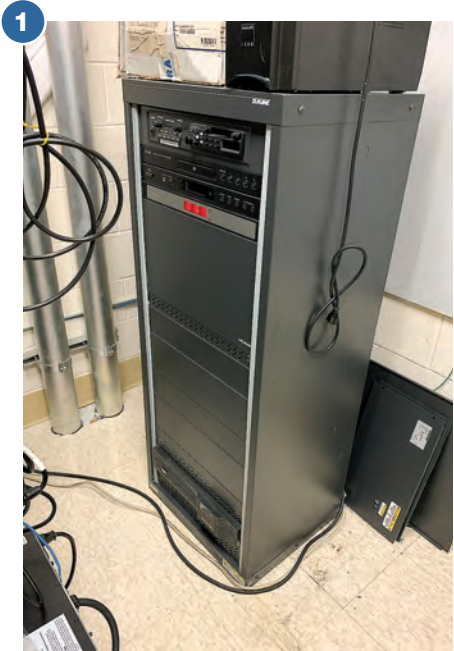
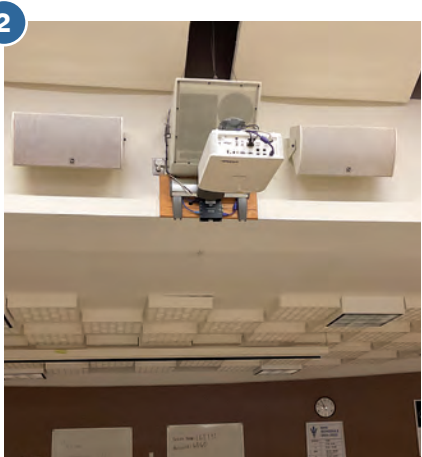
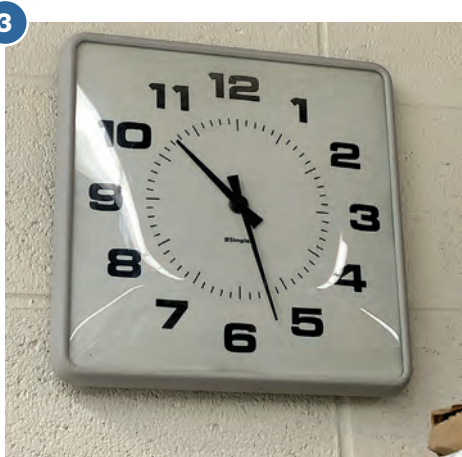
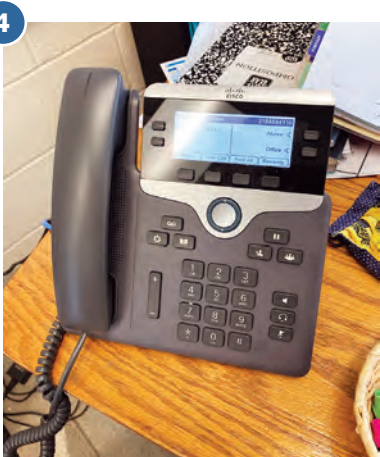
1. Outdated PA headend in the MTR.
2. A Large Group Instruction Audio-Enhancement system in the HS.
3. An analog clock in a High School corridor.
4. A Cisco VoIP handset on a teacher's desk.

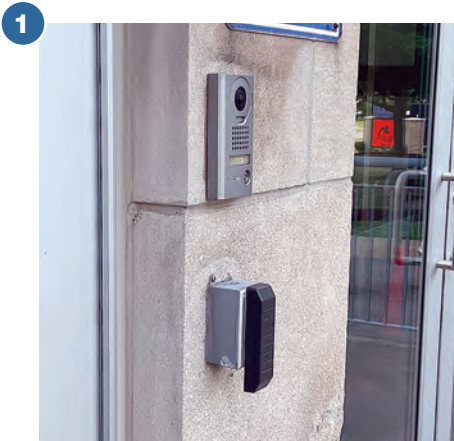
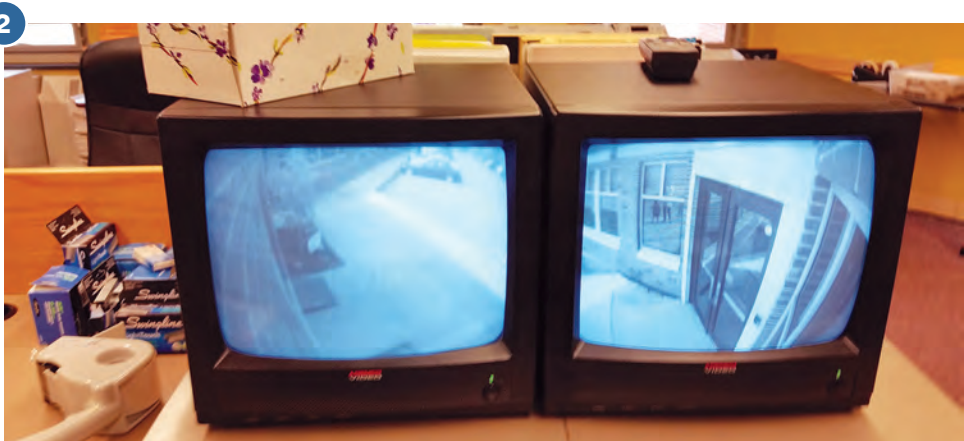
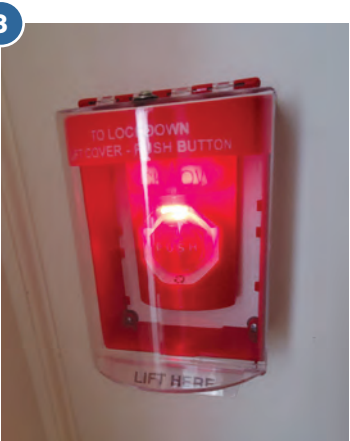
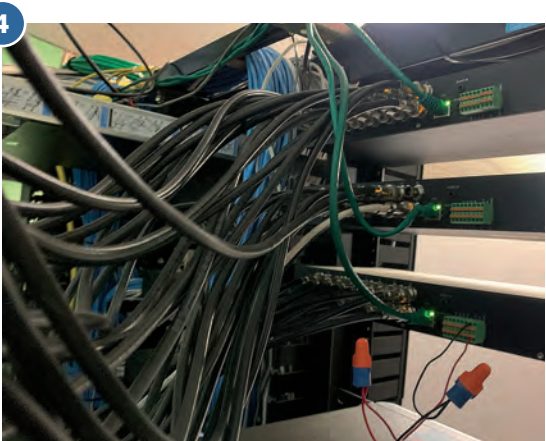
1. A typical card reader and video intercom installed at an exterior door.
2. Video Surveillance monitors are located in the District Office.
3. A typical Lockdown Initiation button in the HS Main Office.
4. Analog video surveillance equipment in the MTR.

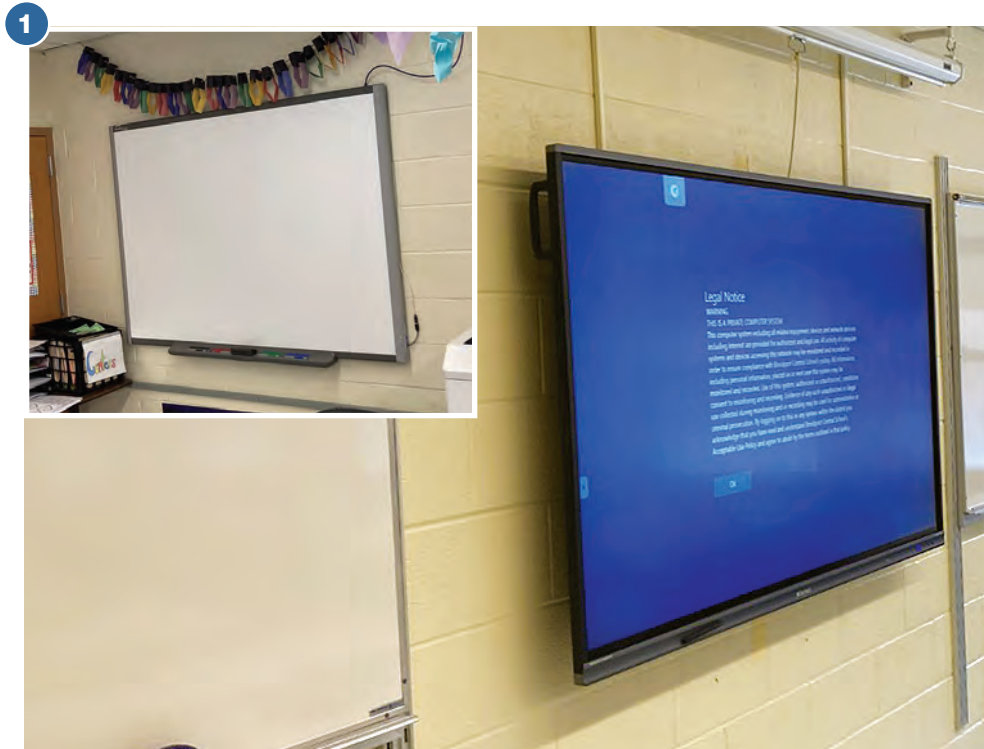
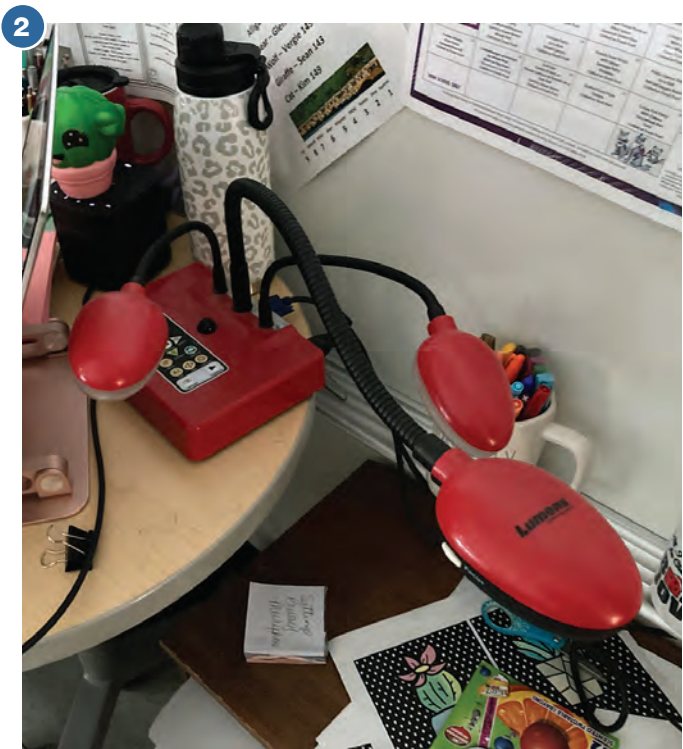
- Outdated SMARTboards (inset) have largely been upgraded to Interactive Flat Panels (IFPs) in the past few years.
- A typical HD document camera in an ES classroom.

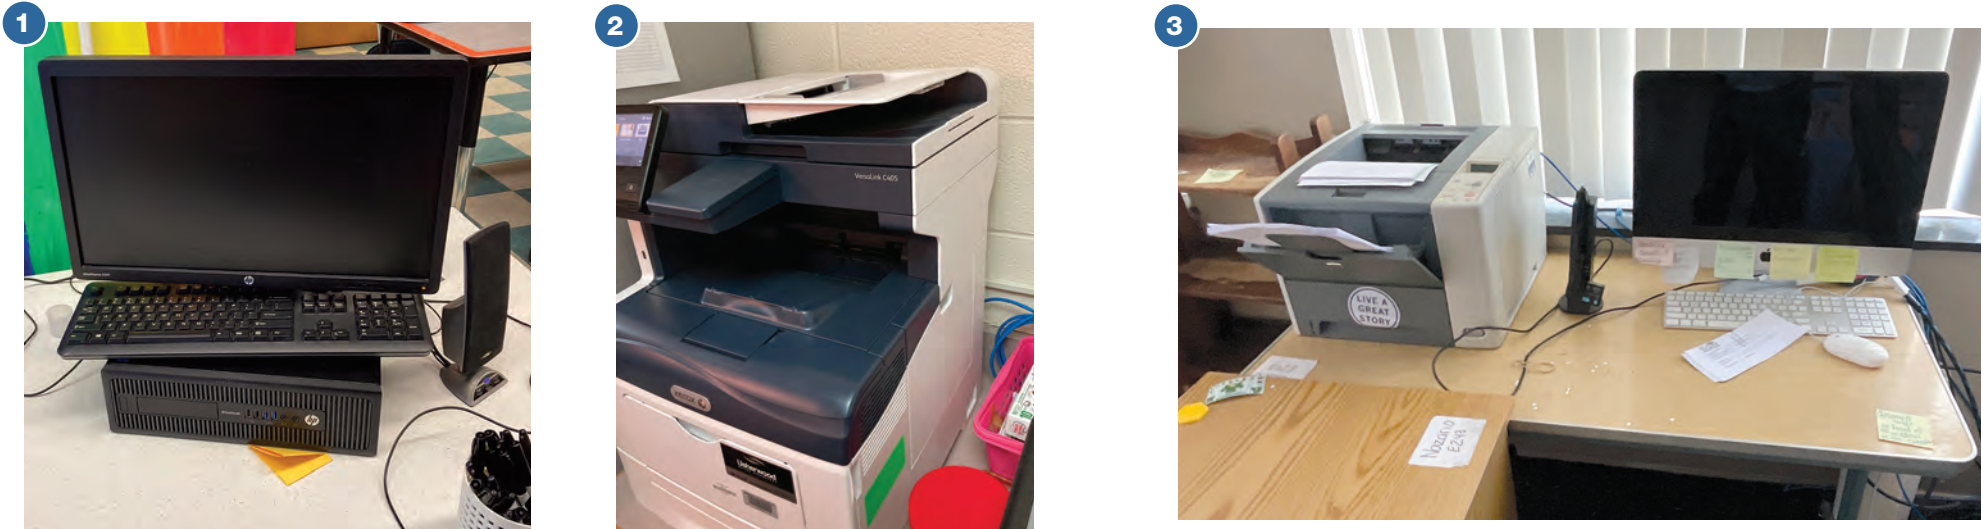
1. A teacher's classroom desktop in a classroom.
2. A typical classroom printer.
3. A newer iMac teacher desktop with a classroom laser printer.
