Comprehensive K12 Technology Planning

ANYTOWN USA **CENTRAL SCHOOL DISTRICT**

- Technology Conditions Survey Report
- Anytown CSD Serving Zone Drawings
- 10-Year Comprehensive Technology Roadmap

January 26, 2026

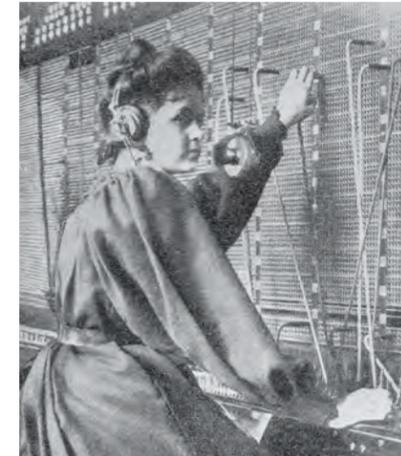
Building-based technology systems have evolved exponentially since wired telephone systems became common in the 1920s. Today's technology systems are crucial to K12 daily operations. Critical components include (above left to right) Telecom Rooms, wired and wireless network equipment, Public Address, Access Control, Video Surveillance, classroom displays, and student devices.

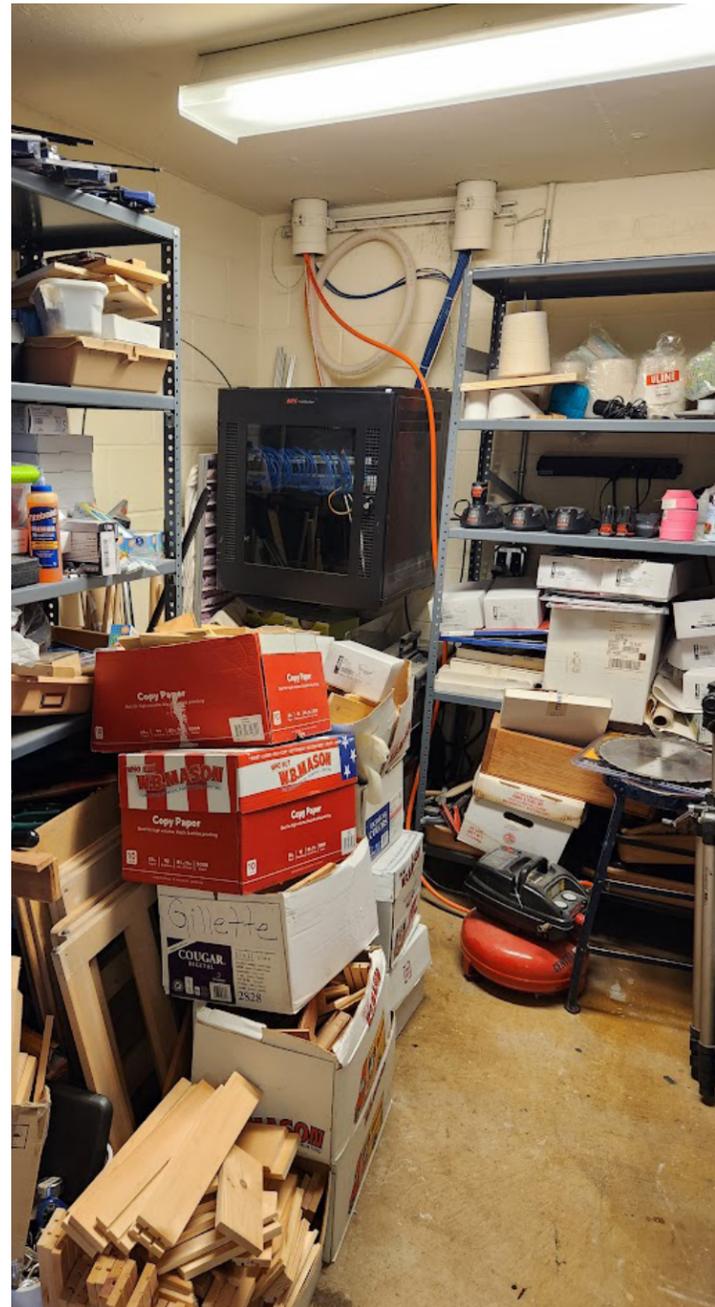
13 factors that influence Telecom Room performance

- 1 **Room size and inadequate rack clearances** inhibit serviceability.
- 2 **Overhead utility pipes** leave racks susceptible to damage from leaks/bursts.

- 3 **Location** lacks direct hallway access and the Serving Zone distance is greater than 300'.
- 4 **Unsecured, shared space** creates a life safety and security risk as well as causing possible accidental damage.

- 6 **No dedicated and redundant power.** Both a dedicated circuit and a power outlet from a building generator are needed.
- 7 **Lack of Uninterruptible Power Supply (UPS)** or emergency power source creates life safety risks during power outages, and reduces equipment lifespan due to a lack of conditioned power.

- 8 **Lack of grounding infrastructure** increases risk of electrical shortage and equipment damage.
- 9 **Overhead cable management** is lacking putting cables at risk of damage.

- 10 **No cable management or correct termination at the rack** can cause operational issues and makes troubleshooting difficult.
- 11 **Poor room construction** with no deck access and poor cable penetrations.

- 12 **Floor tile** is not anti-static increasing risk of Electro-Static Discharge.
- 13 **Hard ceiling** inhibits inspection and serviceability, and limits airflow while trapping heat.

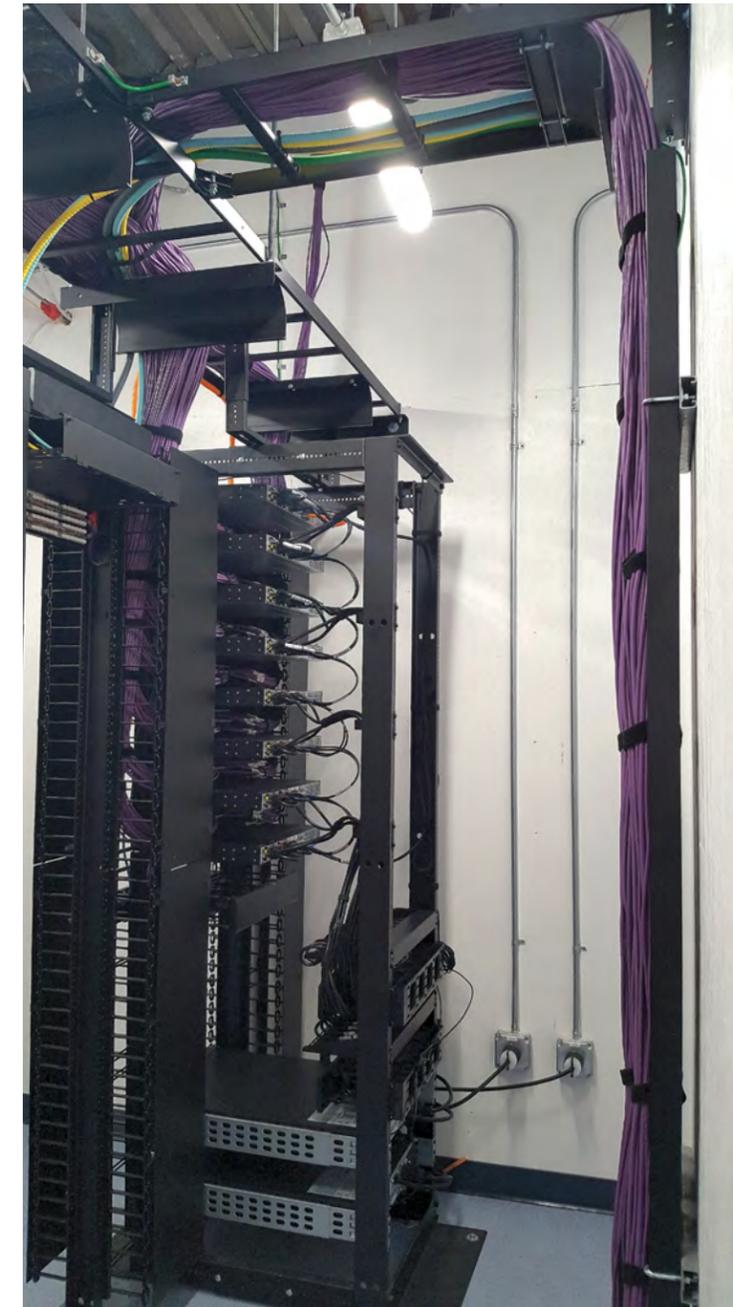
13-Point Checklist for IT Equipment Spaces

1. Size with 3' clear space front and back
2. No risks of water damage.
3. Environment/location/hallway access
4. Secure/dedicated space or locked cabinet
5. Environmental controls
6. Dedicated, redundant power
7. Uninterruptible Power Source (UPS)/ Emergency Management (EM) power
8. Grounding infrastructure
9. Overhead cable management and fire-retardant plywood
10. Cable termination and management at the rack
11. Room construction with walls extended to deck, and compliant, sealed cable penetrations
12. Vinyl-Coated Tile (VCT) flooring
13. Ceiling open to deck with minimum height of 10'

- 11 **Room construction.** Walls extend to deck. Cable penetrations are compliant and sealed (fire stopped).
- 12 **VCT flooring.** Anti-static tile bonded with copper strips

- 13 **Ceiling.** Open to deck with 10' minimum height Above Finished Floor.

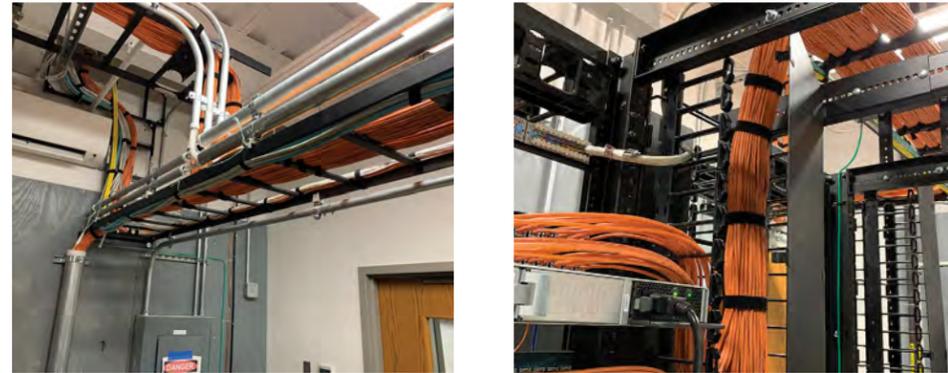
Cable management systems in a TR should accommodate both overhead (right) and vertical (far right) cables.

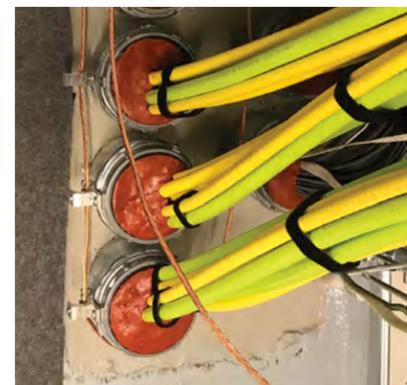
Conduit with proper fill ratio and properly installed firestop. Photo©BICSI. All rights acknowledged.

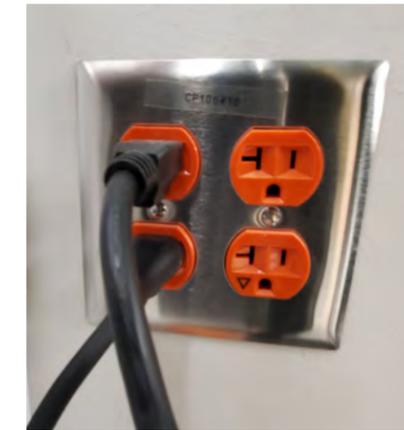
A dedicated electrical circuit with (2) 20A outlets (left) and an emergency generator outlet with proper labeling.

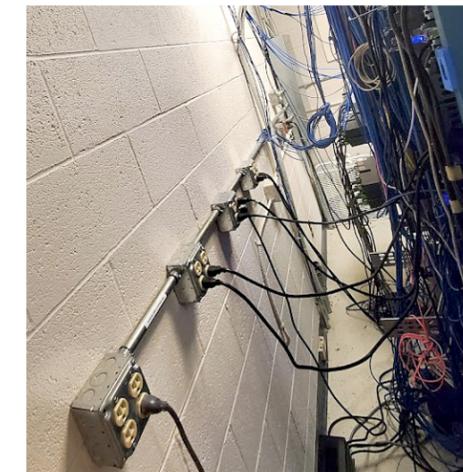
These power cords risk being unplugged when technicians work behind the racks.

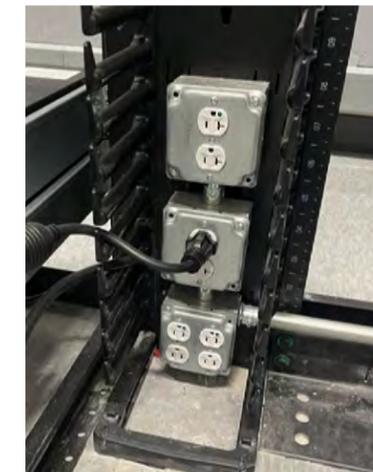
Electrical outlets should be mounted to all racks.

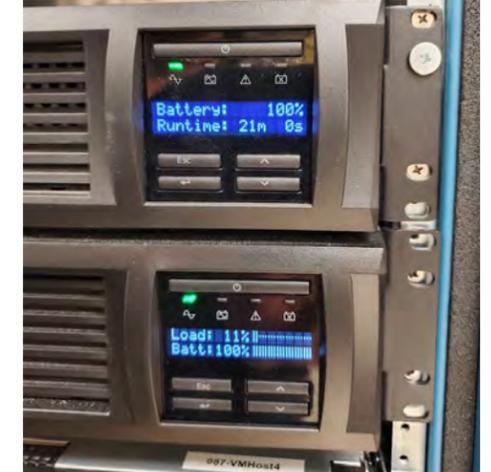
UPS units are rack mounted with no error or alarm messages displayed.

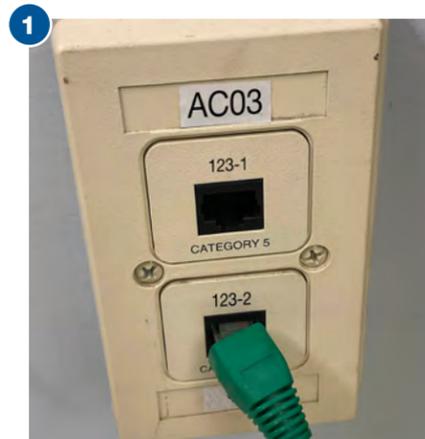
1. Multiple occurrences of performance mismatch. Cat6 patch cable to Cat5 outlet. Labeling conforms to standards with space, panel and port ID.
2. Outdated and non-compliant Cat5 patch panel with poor terminations..
3. Poor cable installation methods.
4. Cables lack adequate support and are poorly installed.

| SYSTEM | SYSTEM GRADE | SUBSYSTEM | SUBSYSTEM GRADE | CURRENT CONDITION | RECOMMENDED IMPROVEMENTS |
|---|---|--|---|--|---|
| Horizontal Cabling | 2.0 | Horizontal UTP Cabling | 1.8 | <ul style="list-style-type: none"> • There is currently a mix of Category 5, 5e and 6 cables with adequate labeling throughout the District. <ul style="list-style-type: none"> – Category 5 is no longer a recognized performance class for network cabling. • Cable installations after the initial construction are not supported to the patch panel point of termination. • Cable performance and termination hardware mismatches observed. • Poor cable termination methods. <ul style="list-style-type: none"> – Performance mismatched cable and termination hardware. – Terminations with excess wire at the IDC. – Keystone jacks not mounted in patch panel frames. – UTP cable terminated with crimp on connectors and plugged directly into switches. | <ul style="list-style-type: none"> • Upgrade all existing Cat5 and 5e cable to Cat6 minimally. • Terminate category 6 and 6A cable with hardware that matches the cables performance category. • Terminate cables in patch panels. |

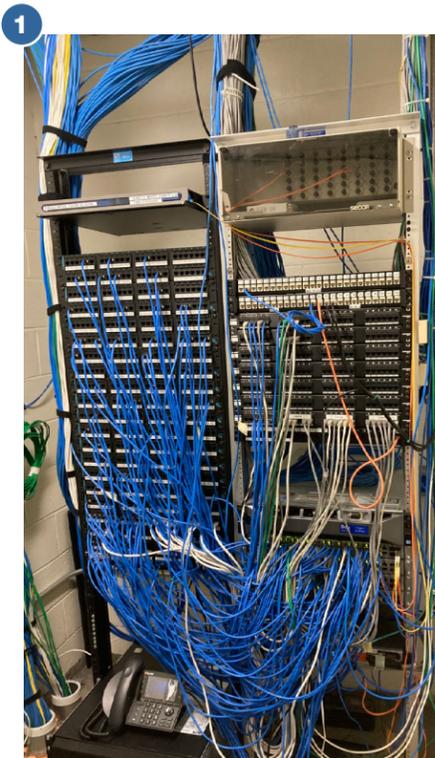
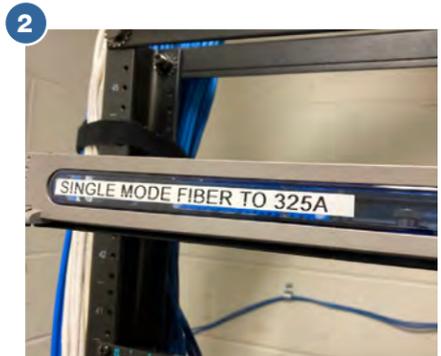
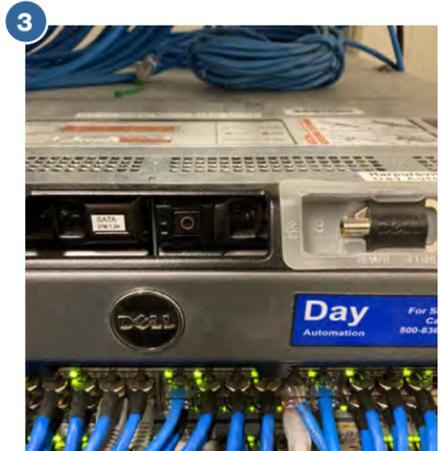
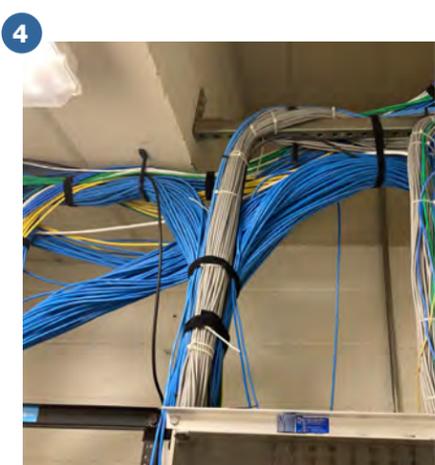
1. Anytown Elementary School

The space is in **fair** condition but requires significant investment to meet industry standards

| CATEGORY | CATEGORY GRADE | CURRENT CONDITION | RECOMMENDED IMPROVEMENTS |
|---|---|---|--|
| 5. Environmental Control | 2.0 | <ul style="list-style-type: none"> The space has a dedicated AC system but no exhaust fan. A dedicated AC system was observed but it was not operational at the time of the survey. | <ul style="list-style-type: none"> Consider installing an exhaust fan to improve air circulation. Confirm that the existing AC system is operational and keep the unit energized. Replace the system if it is not functional. |
| 8. Grounding Infrastructure | 0.0 | No bonding or grounding infrastructure was observed. | Install a grounding and bonding infrastructure with a TGB. Bond all racks, pathways, and equipment. |

- Photos, clockwise from top left:
- The secured space contains (2) open floor-mount racks with poor cable management.
 - The intra-building fiber feeds into this space. Single-Mode fiber connects the 2 TRs in the ES.
 - The video surveillance server is mounted in one of the racks.
 - Overhead cables are not managed by standards-compliant supports.

| CATEGORY | CATEGORY GRADE | CURRENT CONDITION | RECOMMENDED IMPROVEMENTS |
|---|---|---|--|
| 1. Room Size & Rack Access | 3.0 | The room size does not meet industry standards but is functional at its current size. | Reposition equipment racks to achieve minimum recommended front and back clearances. |

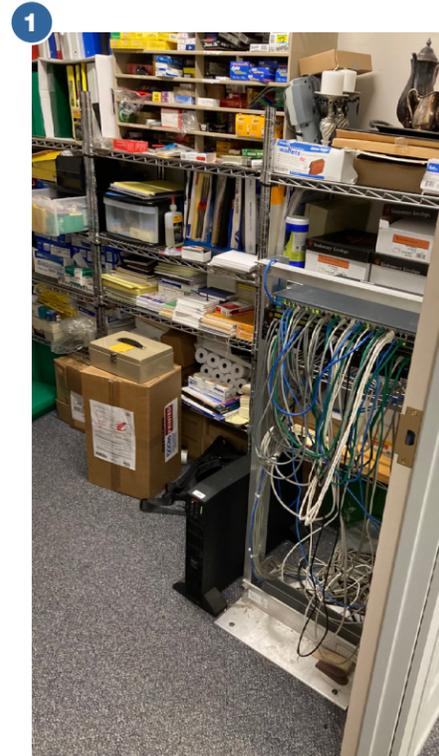
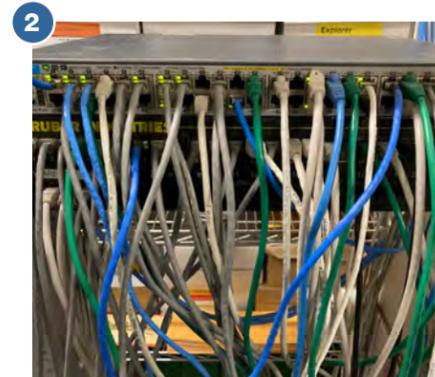
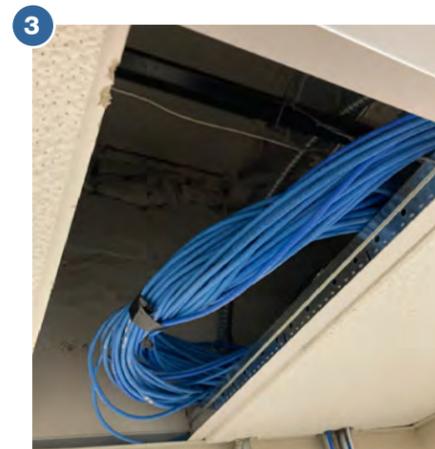
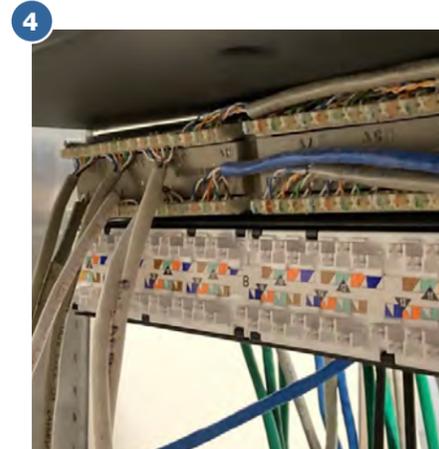
The space is in **poor** condition and is not worth the investment to upgrade the space to industry standards.

| CATEGORY | CATEGORY GRADE | CURRENT CONDITION |
|---|---|---|
| 8. Grounding Infrastructure | 0.0 | No bonding or grounding infrastructure was observed. |

Photos, clockwise from top left:

1. The open free-standing rack is in an unsecured space shared with the storage of non-IT items.
2. Poorly managed, primarily Cat5 cables in the rack.
3. A coil of Cat6 cable above the ceiling tile appears destined for installation in this space.
4. Cables are improperly terminated.

1. Abandon the space.
2. Identify a new space that meets industry standards.
3. Construct a new compliant TR in the space.
4. Move all IT equipment to the new TR.
5. Remove all abandoned equipment and cables from the space.

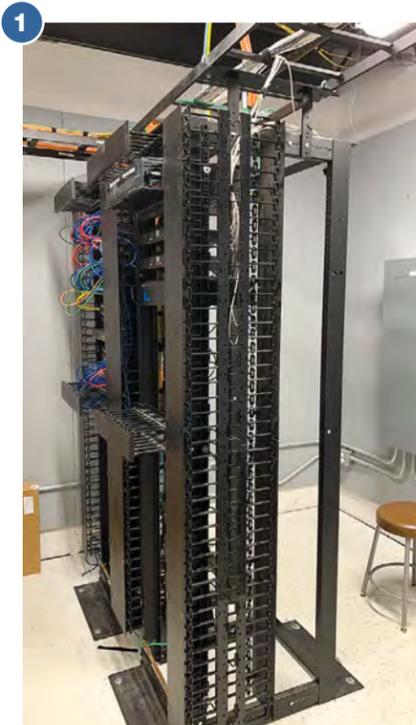
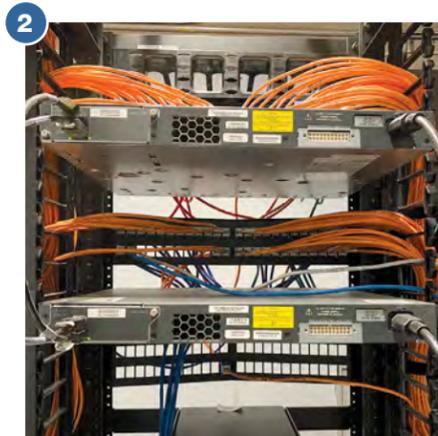
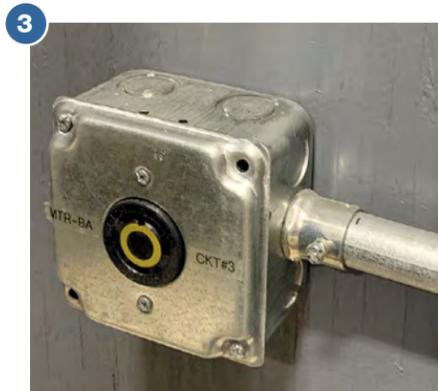
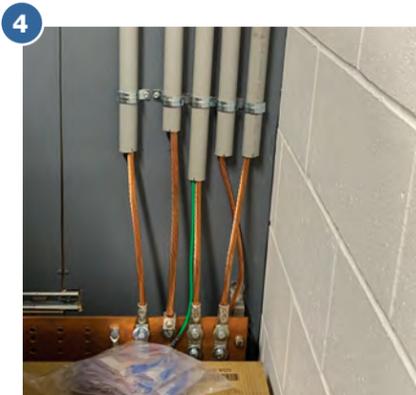
The space is in **good** condition and requires moderate upgrades to meet industry standards.

Photos, clockwise from top left:
 1. The dedicated secure space includes (3) newer equipment racks.
 2. The racks include properly installed cable lengths and management.
 3. A properly labeled electrical outlet from the building's emergency generator.
 4. A properly installed grounding bar with all components correctly connected.

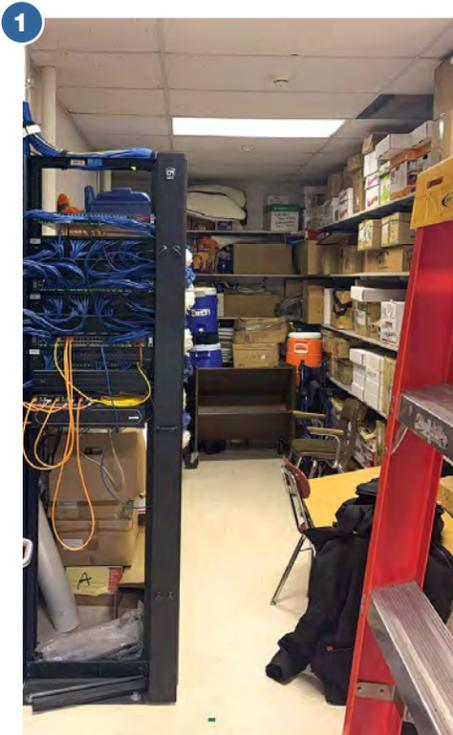
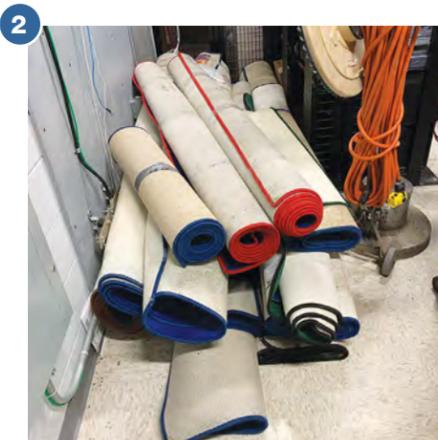
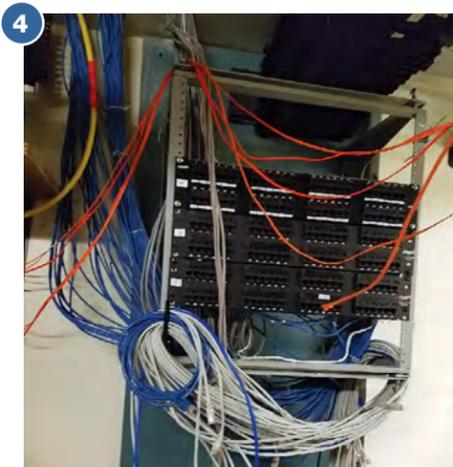
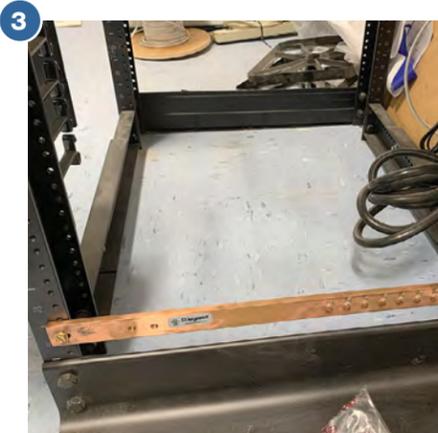
- Photos, clockwise from top left:
- Unsecured space shared with office supply storage.
 - Rugs are stored in close proximity to IT equipment racks.
 - A grounding bar is installed in the rack but no equipment is connected to it.
 - Abandoned legacy cable installed in the space.

RECOMMENDATION
Dedicate and upgrade the current space.

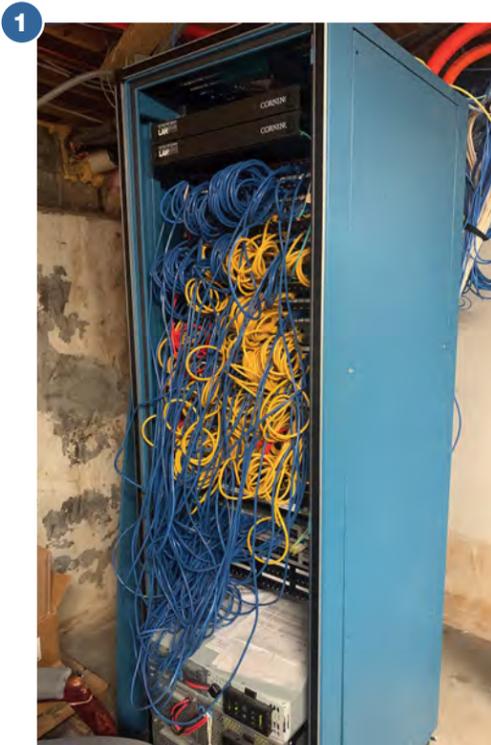
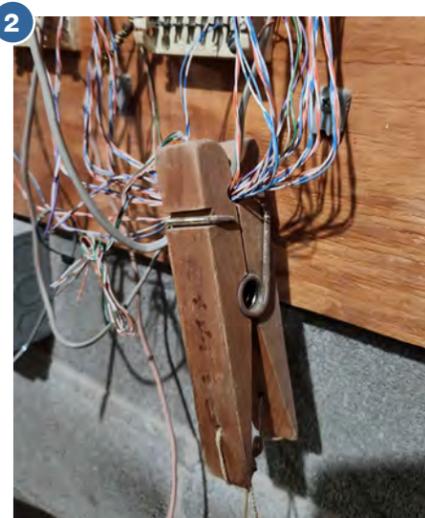
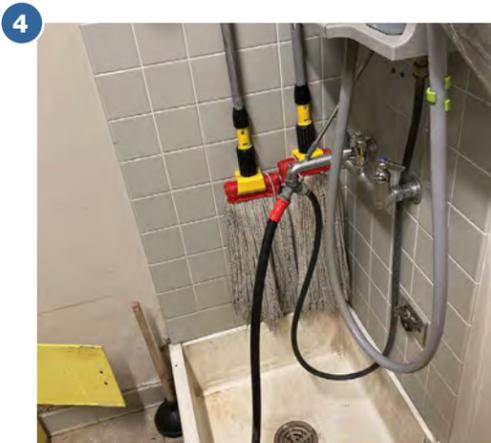
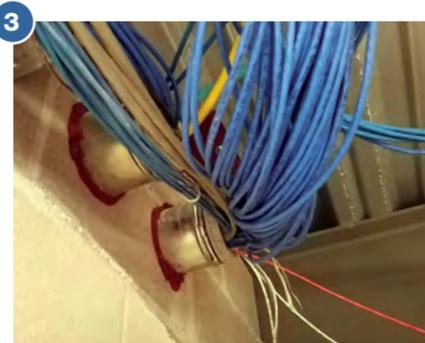
- Photos, clockwise from top left:
- The open rack is in an unsecured area that is shared with custodial items.
 - While functional, the oversized clothespin does not meet industry standards for cable management.
 - Conduits are filled beyond capacities.
 - There is a janitorial slop sink in the same space as the equipment.

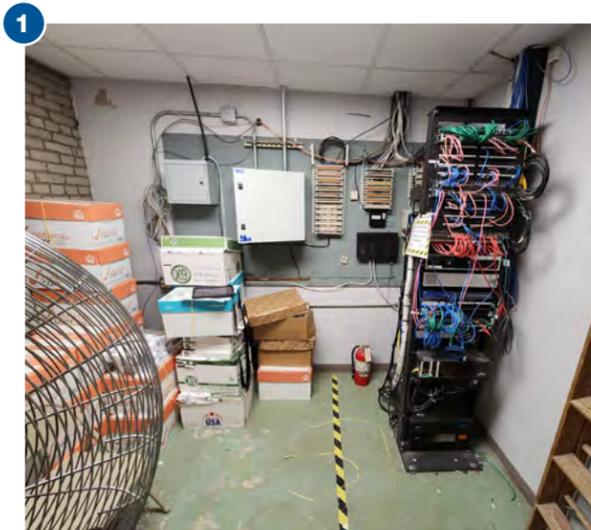
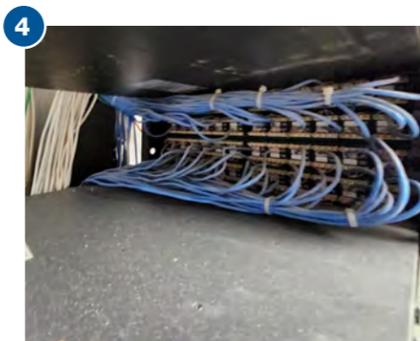
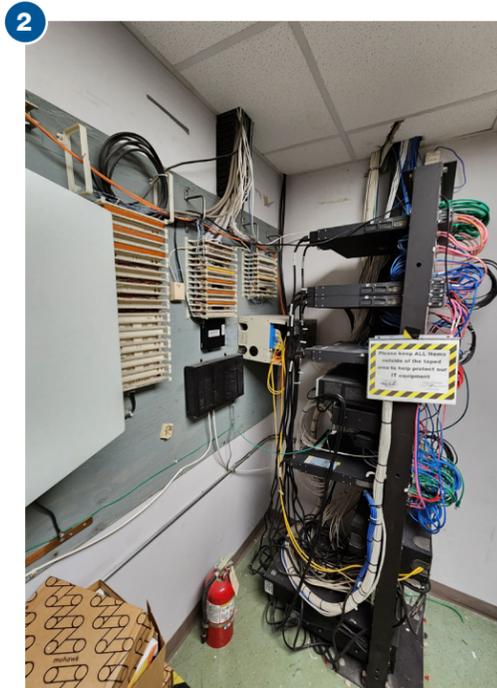
- The open floor-mount rack is installed in a space shared with non-IT items and accessible to non-IT staff.
- The rack's poor position inhibits rack clearances and access to the inter-building fiber housing.
- Insufficient vertical cable management for incoming horizontal cabling.
- The space is extremely dusty.

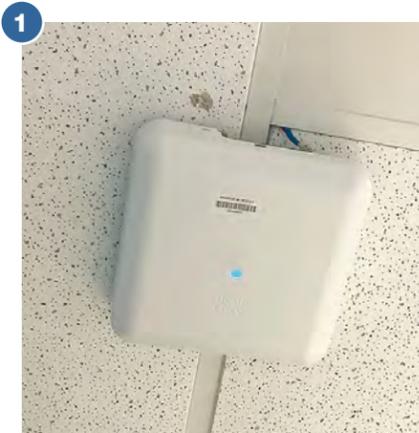
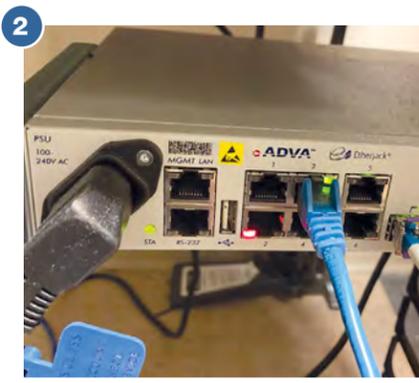
1. A ceiling-mounted WAP in an Elementary School classroom connected with only (1) Cat 6A cable.
2. The ISP connection in the High School MTR.

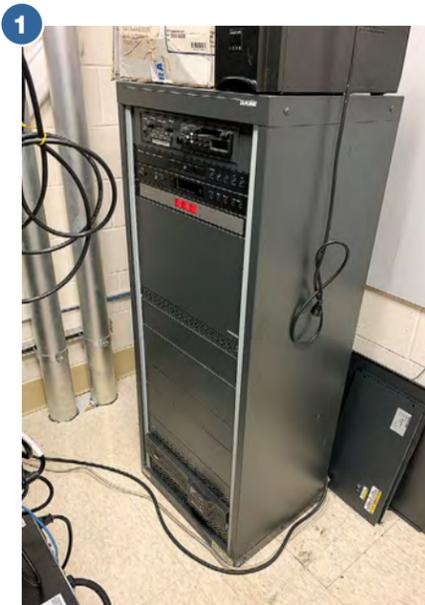
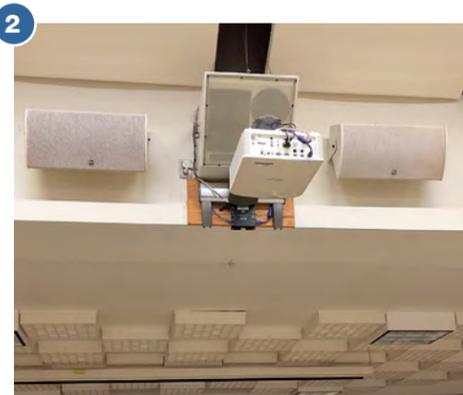
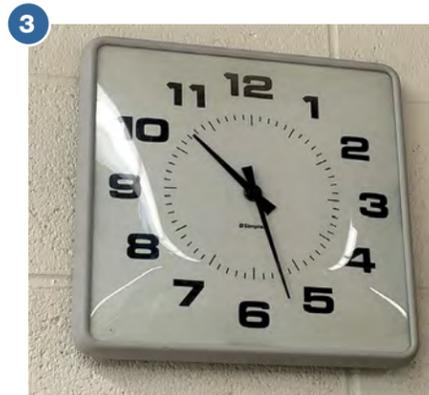
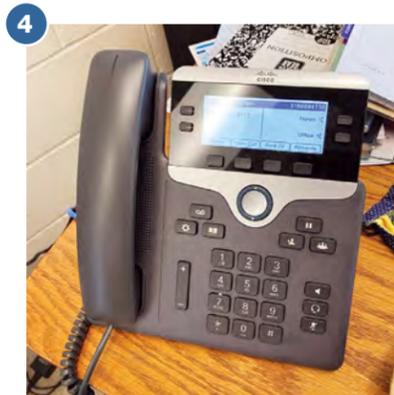
1. Outdated PA headend in the ES MTR.
2. A Large Group Instruction Audio-Enhancement system in the HS.
3. An analog clock in a High School corridor.
4. An Acme VoIP handset on a teacher's desk.

| SYSTEM/SUBSYSTEM | SUMMARY OF CURRENT CONDITIONS | SUBSYSTEM GRADE | SYSTEM GRADE | RECOMMENDED IMPROVEMENT SUMMARY |
|--|---|---|---|--|
| Public Address (PA) | The district's analog PA systems are at End-Of-Life. | 2.0 | 1.9 | Replace the PA system with a full IP or IP/analog system per the <i>10-Year Roadmap</i> . |

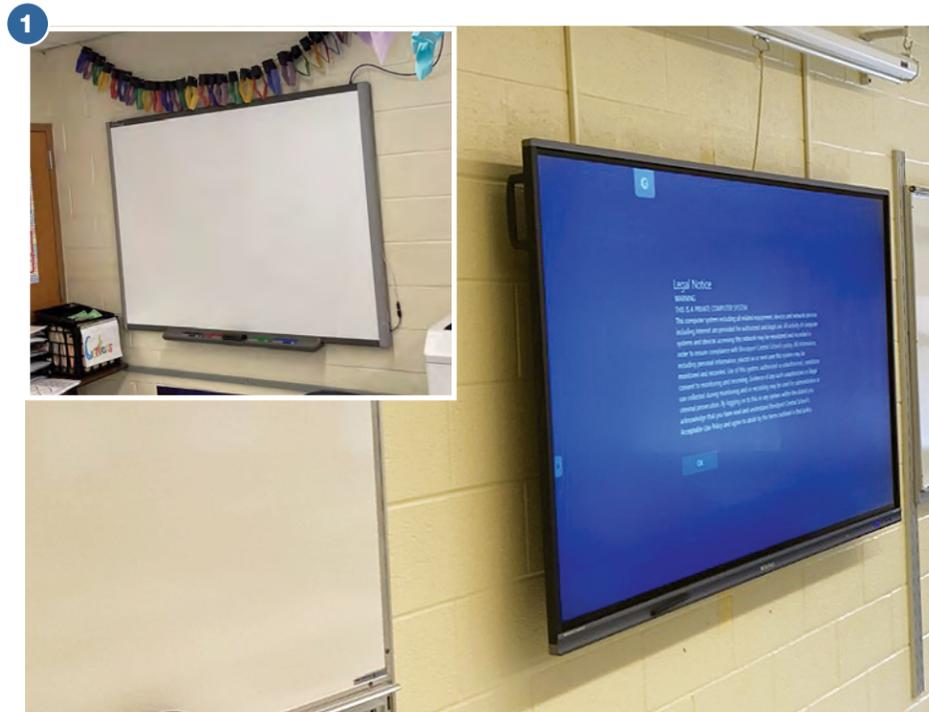
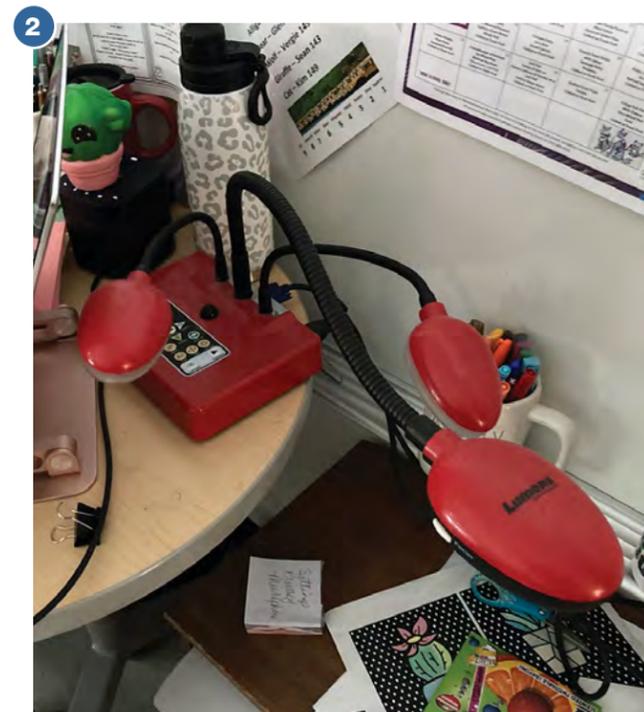
- Outdated SMARTboards (inset) have largely been upgraded to Interactive Flat Panels (IFPs) in the past few years.
- A typical HD document camera in an ES classroom.

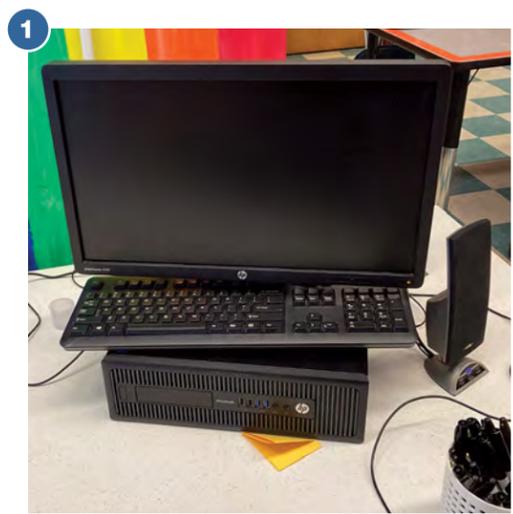
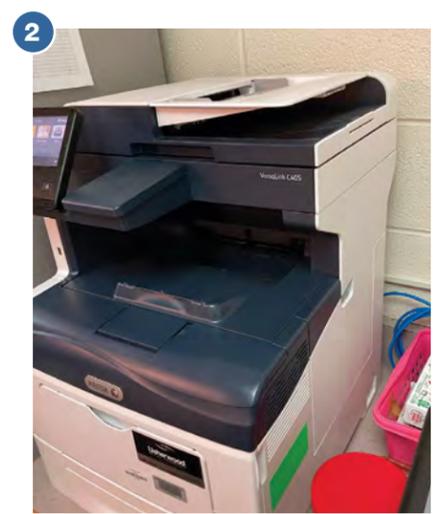
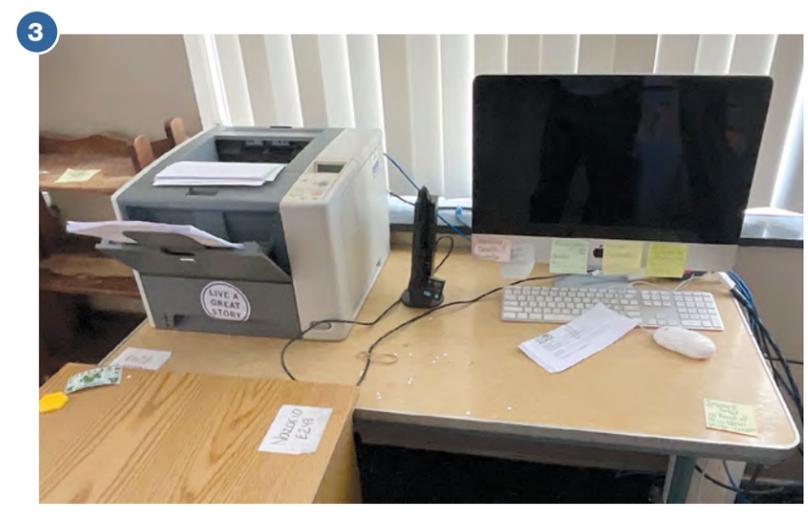
Photos left to right:
 1. A teacher's classroom desktop in a classroom.
 2. A typical classroom printer.
 3. A newer iMac teacher desktop with a classroom laser printer.
